# Manhole Inspection Summary

Manhole # S49E\_\_011MH

Insp Date: **6/28/08 9:09 AM**

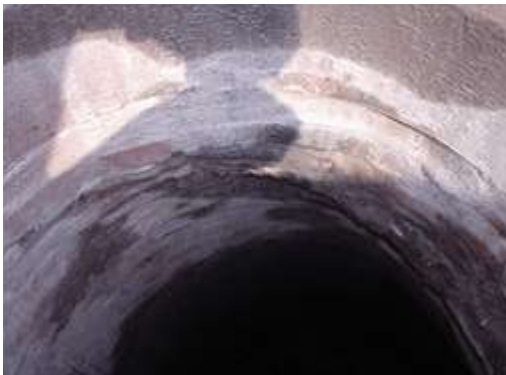
Defect 1

**Frame** Offset: **0.5** (in.) Condition: ☐ Sound ☐ Cracked ☒ **Leaks**

frame leaks

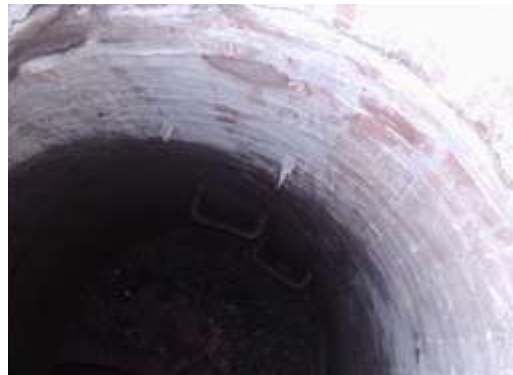
Defect 2

**Steps** Count: **4** Missing: **1** ☒ **Corroded**

missing steps

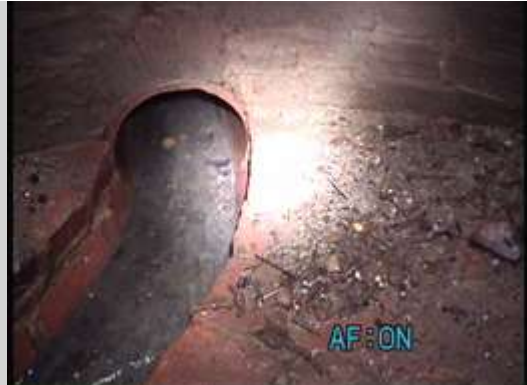
12 O'Clock Outflow

8 in. Circular Gravity Sewer  
Pipe Out @ 12 O'Clock

Pipe Height: **8.4** (in.) Rod and Bar (Angled)  
Pipe Material: **Clay** ☐ Pipe Lined  
Invert Depth: **9.90** (ft.) Flow Characteristics: **Fast**  
Deposits: ☒ None ☐ Mud ☐ Sludge ☐ Debris ☐ Grease  
Silt Depth: (in.) Deposits Extent:  
Infiltration: **None** Pipe Seal Cond: **Sound**

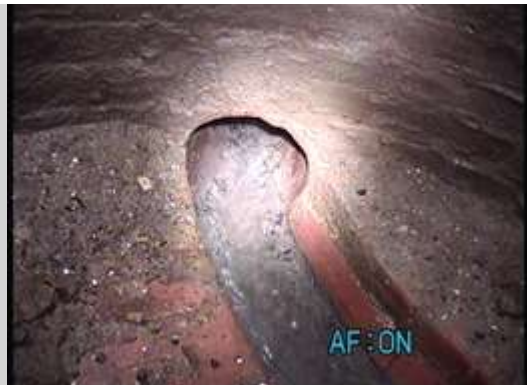
9 O'Clock Inflow

8 in. Circular Gravity Sewer  
Pipe In @ 9 O'Clock

Pipe Height: **8.4** (in.) Rod and Bar (Angled)  
Pipe Material: **Clay** ☐ Pipe Lined  
Invert Depth: **9.90** (ft.) Flow Characteristics: **Fast**  
Deposits: ☒ None ☐ Mud ☐ Sludge ☐ Debris ☐ Grease  
Silt Depth: (in.) Deposits Extent:  
Infiltration: **None** Pipe Seal Cond: **Sound**
